## RISCA MUSEUM AND MONMOUTHSHIRE CANAL (CRUMLIN ARM) REPORT ON VISIT 25/6/2022.

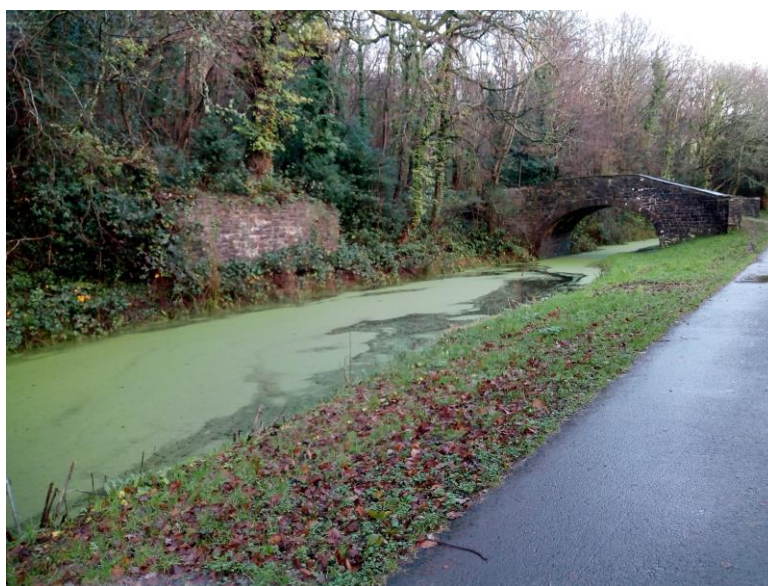
A number of old limekilns and quarries were shown on the 1880's OS map, some of which were no longer extant. All clues as to some of the types of canal traffic in its heyday. The old quarry at Graig was prominent with a possible loading bank alongside the canal overbridge. See photo, right.

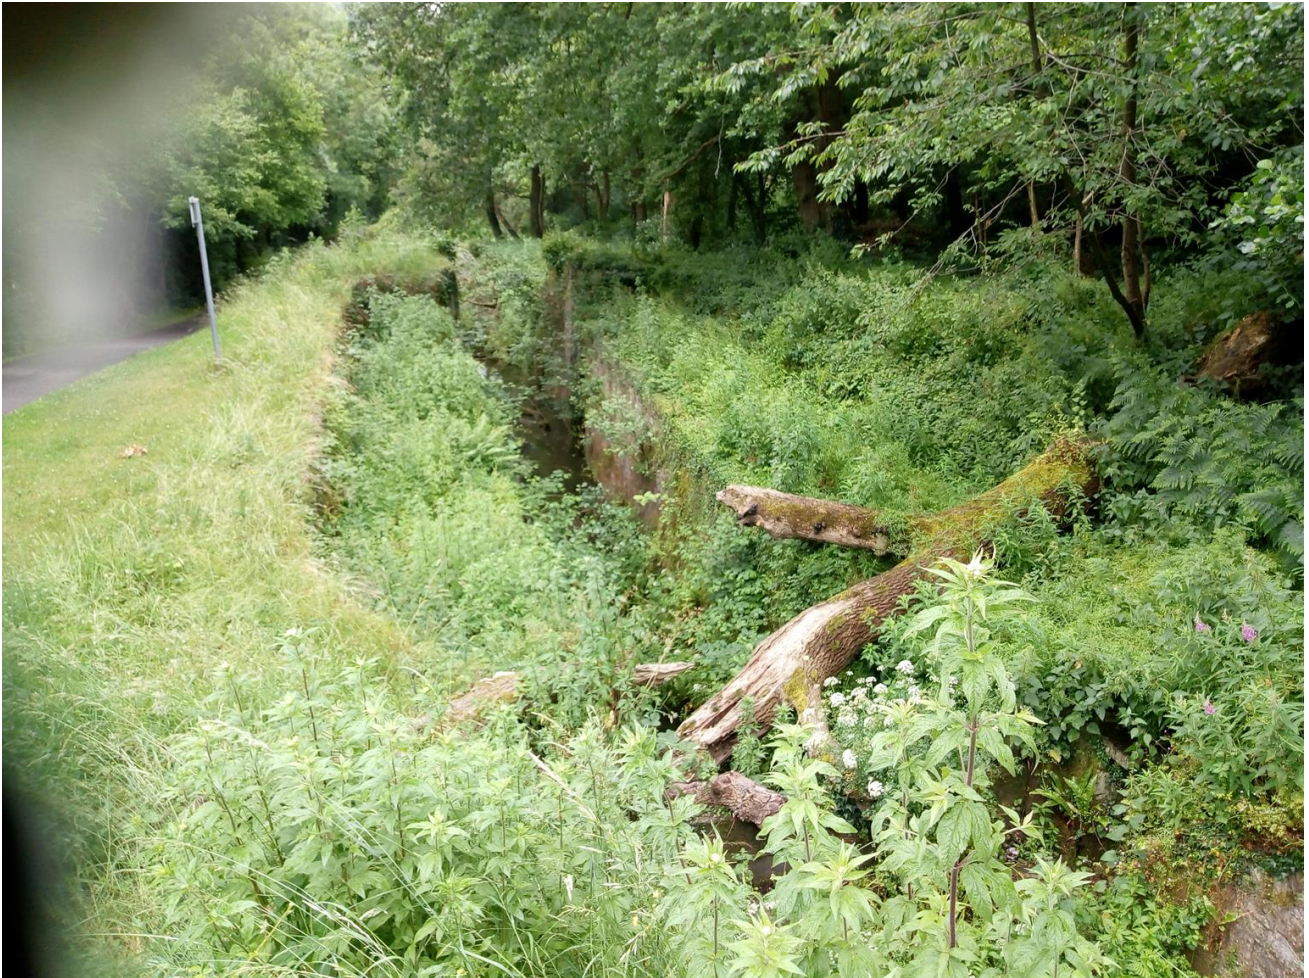
**Lock 11, viewed looking south-east.**

There was some poring over plans, trying to work out how the flight would have been operated. Particularly where three locks, 10, 11 and 12, adjoined each other. The middle lock chamber was widened out at high level with “shelves” to enable boats to pass each other within the chamber.

There was considerable discussion as to how it might have been worked. Since the lock would have to be kept full while the passing places were in use to prevent grounding, it is surmised that the upcoming boat would first enter lock 11 which would then be filled and the boat moved into the passing place within the lock. The downgoing boat could then enter the lock and take the other passing place, after which the upcoming boat would enter lock 12. The downgoing boat would then move to the middle and the lock would have to be emptied slowly and carefully. If the boat was not exactly in the middle and grounded on either of the ledges, a capsize would be inevitable!

At fourteen locks, the canal rises 160 ft over a distance of half a mile, the locks being generally in pairs with the shortest possible distance inbetween the pair. A side pond between each pair of lock chambers provided a reservoir so that water did not go to waste when a lock was emptied. Between a pair of locks and the next pair there was enough space for one boat to pass another, but not much more than that.
